UNITED STATES DEPARTMENT OF AGRICULTURE
BULLETIN No. 1107

THE LEAD-CABLE BORER
OR "SHORT-CIRCUIT BEETLE"
IN CALIFORNIA

H. E. BURKE, Entomologist, R. D. HARTMAN, Field Superin-
tendent in Insect Control, and T. E. SNYDER, Entomologist,
Forest Insect Investigations, Bureau of Entomology

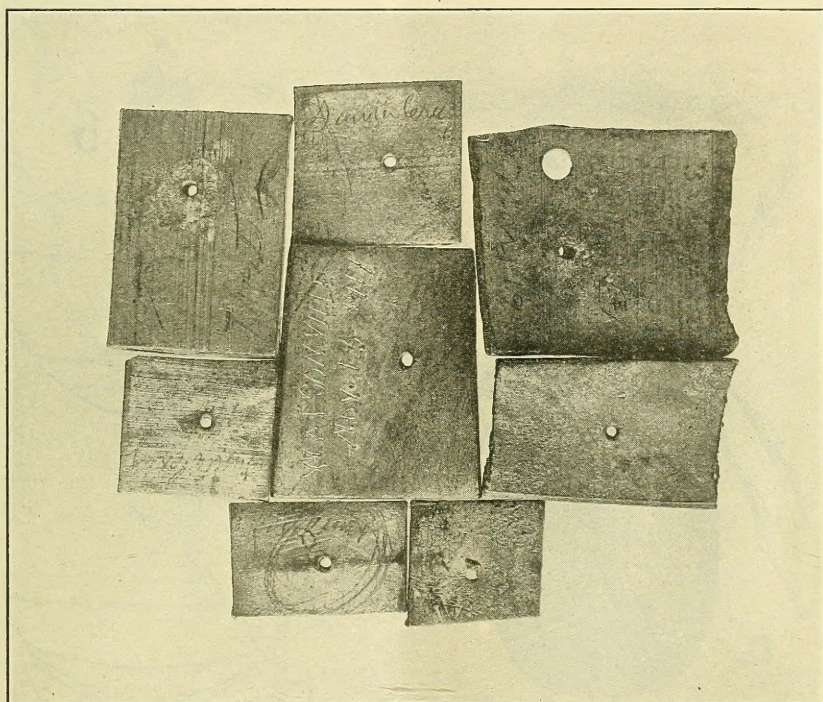
Damage to the lead sheathing of aerial telephone cables consists of perfectly round holes about 2.5 millimeters (0.1 inch) in diameter which extend through the lead sheathing from the outer surface to the paper insulation of the wires within. (Pl. VI, Fig. 3; Text Fig. 3.) Cables of various diameters are attacked. In practically every case the hole is made through the lower side of the sheath close to where the suspending ring or metal or marline hanger supports the cable. In a few cases the damage is done where the cable has been scarred or roughened or where an upright cable has been fastened to the poles by clamps. In a number of cases where attempts had been made on the sheathing the work was abandoned before the sheathing was penetrated. In cases where the sheathing is penetrated, moisture is very readily drawn in to the wires and the entire supply of electric current may be short-circuited. If the hole happens to be in the proper location a great deal of moisture enters and the cable may be ruined for 15 to 20 feet. Particularly in case of slack cable or those on grades the moisture sometimes penetrates and soaks the insulation for long distances. This necessitates cutting out the cable, splicing

FIG. 3.—Holes bored in the lead sheathing of aerial cables by the California lead-cable borer (*Scobicia declivis*) at various localities in California. Natural size.

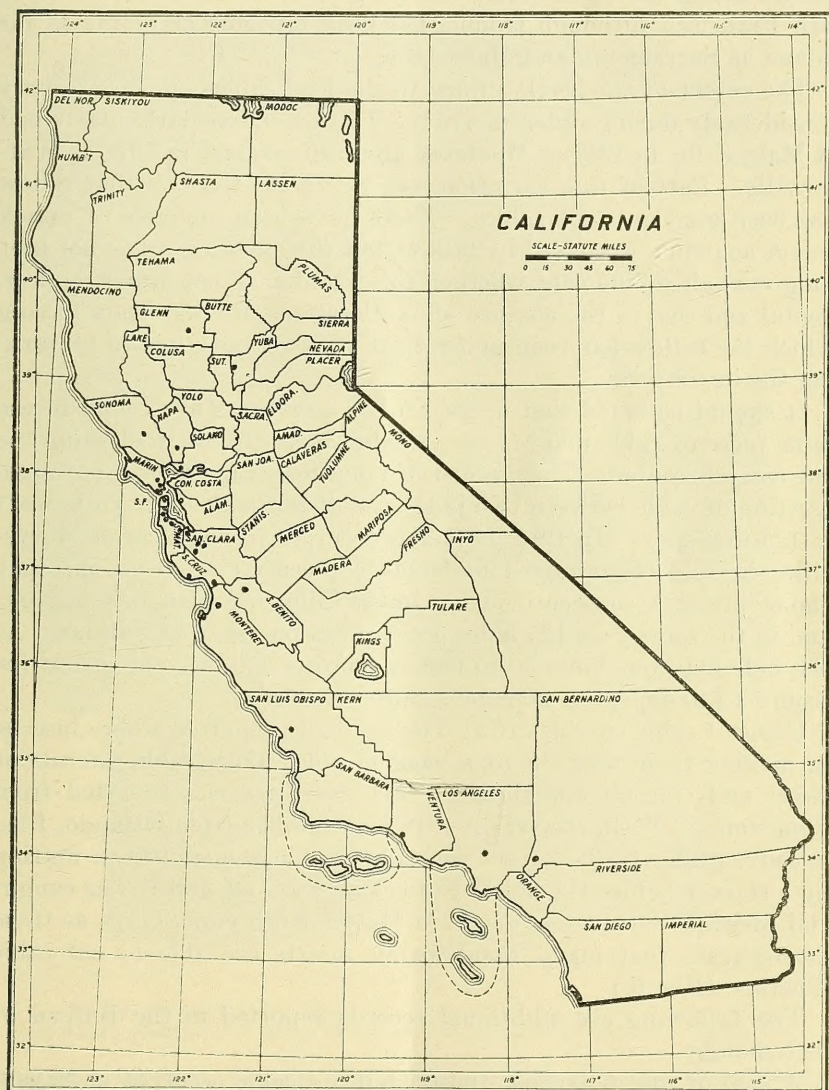
FIG. 5.—Map showing distribution of trouble caused by the California lead-cable borer.

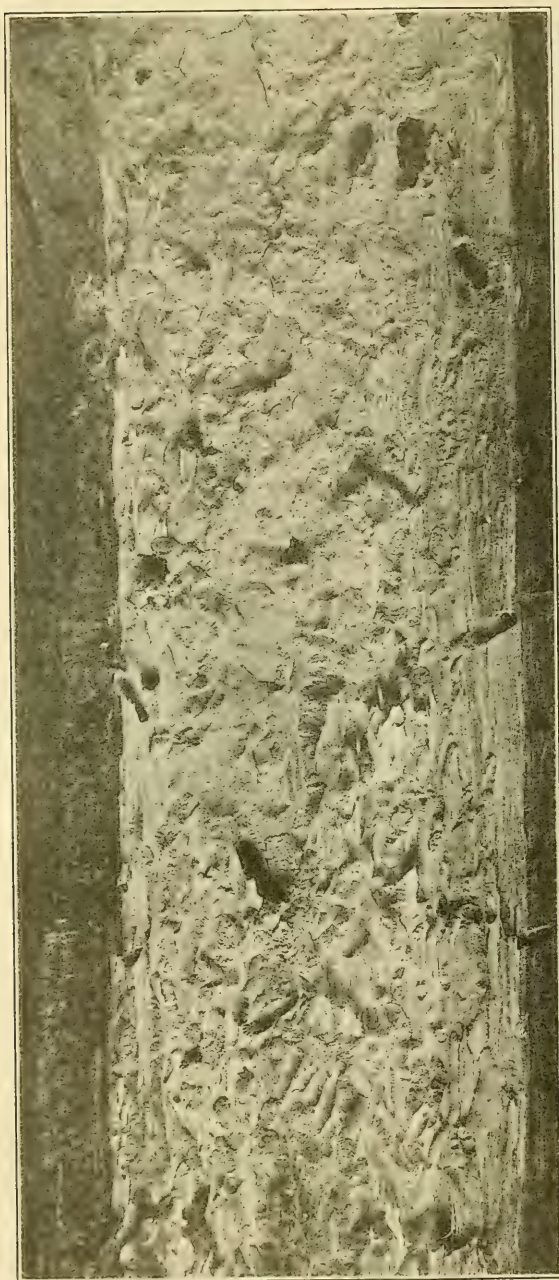
FIG. 7.—Work of the California lead-cable borer in California live oak (*Quercus agrifolia*), Los Gatos, Calif. Note that the wood is "powder-posted." The larger holes were made by a roundheaded borer. Natural size.

are through with a section of wood, nothing remains but the bark and enough solid wood to hold the mines together. All of the rest is reduced to numerous holes (the egg galleries and exit holes) and the winding larval mines closely packed with the meal-like boring dust. (Figs. 7 and 8.)

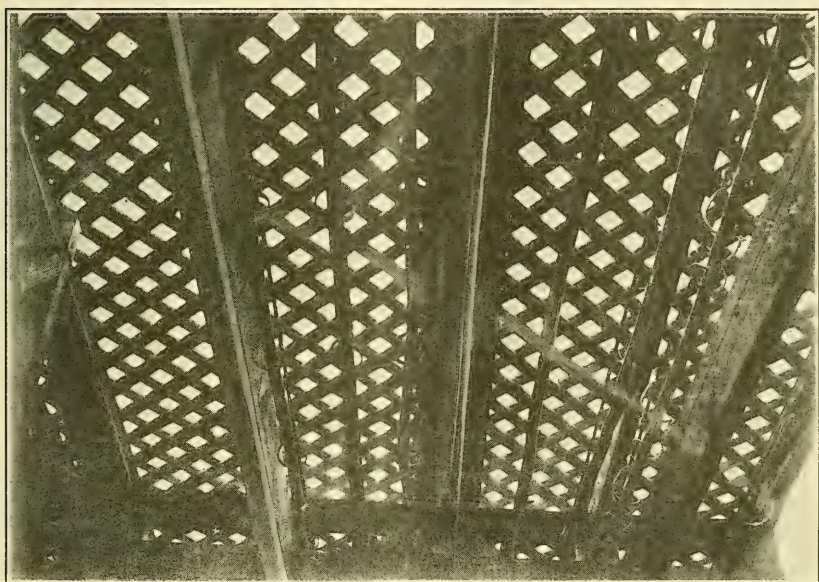
Other adults were left to fly freely in the large cage to attack the suspended cables of different alloys hung on various types of rings, wire and tape. (Fig. 15.) Several pairs of these adults infested the corks from 100-millimeter vials, constructing their galleries in the corks.¹³ The beetles entered the heavy beams (Southern yellow pine) supporting the cage and the old California laurel limbs. They did not attack the suspended cables.

FIG. 15.—Interior of experimental cage at Falls Church, Va., showing lead-sheathed cables of different alloy composition suspended on different types of rings from beams of roof.

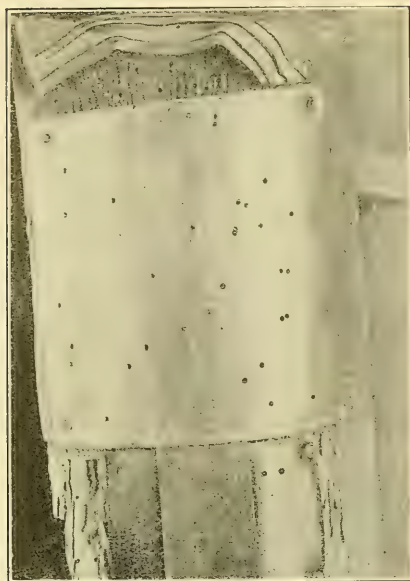
FIG. 1.—Infested section of oak covered with alloys and building paper in layers, but with narrow strip of sheet steel that was placed between layers of lead alloy and top layer of alloy removed. Shows beetles in holes where they were stopped by steel. Photograph by H. E. Burke.

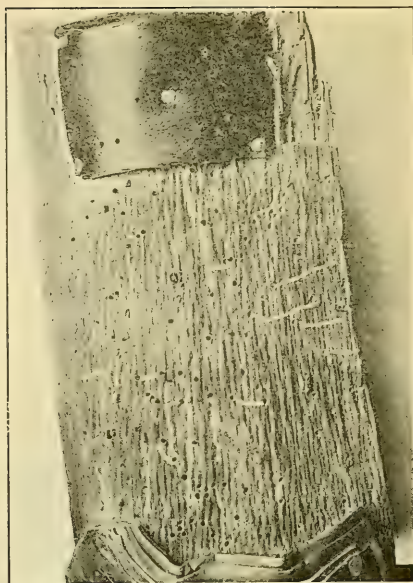
FIG. 2.—Section of infested oak with all the layers of alloy removed, showing how many of the beetles attempted to escape from the sides instead of boring through the alloys. Photograph by H. E. Burke.

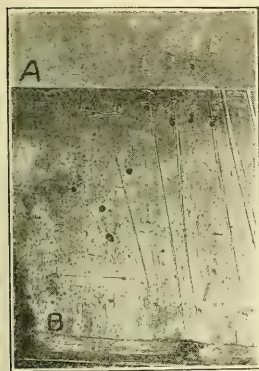
FIG. 3.—*A*, sheet of lead alloy which was covered by the sheet of zinc, *B*. Most of the beetles were unable to penetrate the zinc and stopped in *A*. One, marked *A* on sheet *B*, did penetrate the zinc. (Table 1, No. 25b.) Photograph by H. E. Burke.

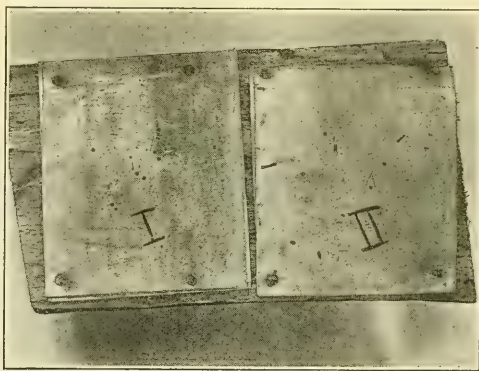
FIG. 4.—Sheets of lead alloys tacked over infested wood. *I* was covered with a sheet of lead carborundum coated on the upper or outer side. It did not seem to stop the beetles at all. Note clean-cut holes. *II* was covered with a sheet of lead carborundum coated on the inner side next to it. It seemed to stop most of the beetles. Note how they mined to the side in attempting to escape boring through it. (Table 1, Nos. 2a, 2b.) Photograph by H. E. Burke.

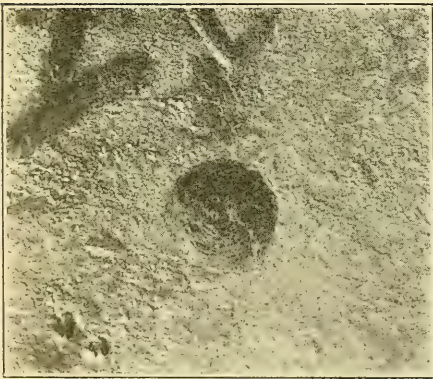
FIG. 3.—Typical beetle mine or single exit burrow in lead sheathing, enlarged $6\frac{1}{2}$ times. Beetle had mined about two-thirds through the sheathing. Photograph by R. D. Hartman.

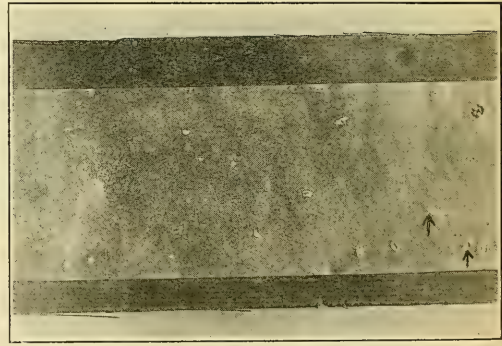
FIG. 4.—First layer of sheet zinc after being removed from infested section, showing 31 attempts, of which 2 were successful, in penetrating one thickness. These are designated by arrows. Three-tenths natural size. (Table 2.) Photograph by R. D. Hartman.

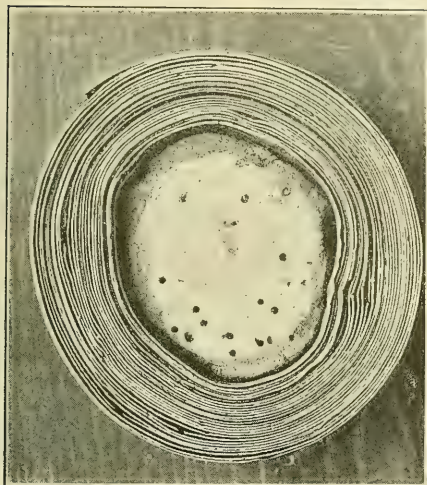
FIG. 1.—Method of wrapping infested oak with lead sheathing to determine number of thicknesses beetles are able to penetrate in emerging. Larval mines in wood and emergence holes of beetles in end of section. (Table 2, No. 55a.) Photograph by H. E. Burke.

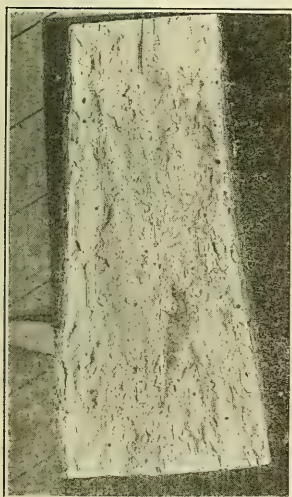
FIG. 3.—Work of beetle and larvæ in infested section of live oak. Larval mines and egg galleries. Longitudinal section. Photograph by H. E. Burke.

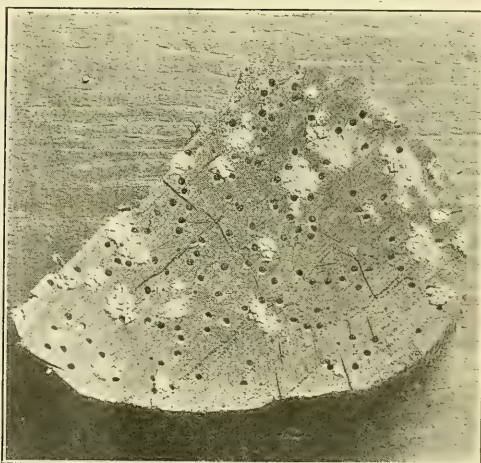
FIG. 4.—Cross section of infested oak, showing how the beetles sometimes emerge at the end of a section. Piles of dust indicate the work of the associated larvæ of the powder-post beetle *Lyctus planicollis*. Photograph by H. E. Burke.

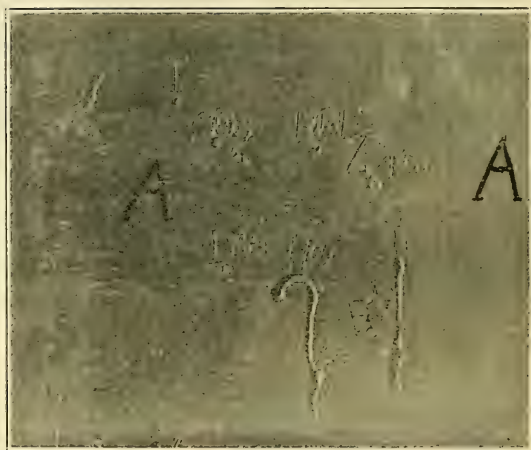
FIG. 3.—First two thicknesses of the three treated lead sheathings after being removed from infested section and manner in which beetles stopped as successive thicknesses were reached. Upper, embedded carborundum, where 17 beetles started in first thickness and 14 reached the second. Middle, tin-coated section, where 14 started in the first and 6 reached the second thickness. Lower, copper-coated section, with 16 and 12 penetrations, respectively. One-fifth natural size. (Table 2, Nos. 54, 54c, 54b.) Photograph by R. D. Hartman.

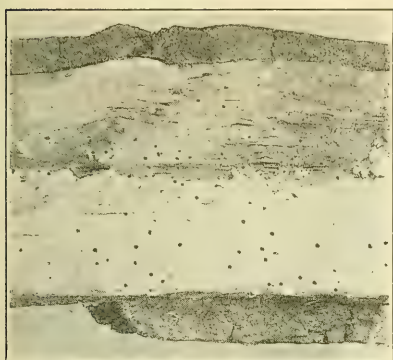
FIG. 1.—Section of infested oak with half of surface coated with tallow one-fourth inch thick. The beetle emerged through it without trouble as long as it was cold and hard. (Table 4, No. 8.) Photograph by H. E. Burke.

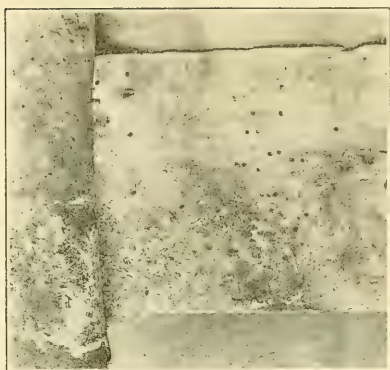
FIG. 2.—Part of roll of alloy, one-half of which was covered with tallow before it was rolled around infested wood. Holes are clean in untallowed section. A number of beetles were caught and died in the tallow when it was softened by the heat. (Table 3, No. 11.) Photograph by H. E. Burke.

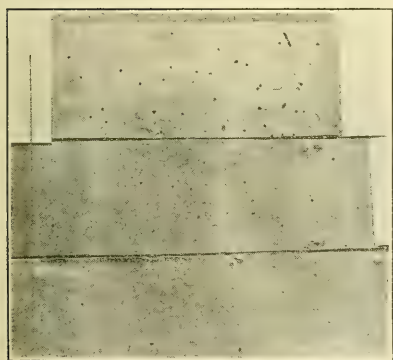
FIG. 3.—Layers No. 1, No. 2, and No. 23 of lead alloy rolled 27 times around an infested section of oak. Shows how the numbers of beetles penetrating the alloy kept diminishing as thicknesses increased. Thirty-seven went through the first, 14 through 12, and only 3 through 23 thicknesses; two of these went through the 24th but were stopped by the 25th. This was the greatest penetration obtained. (Table 2, No. 55a.) Photograph by H. E. Burke.

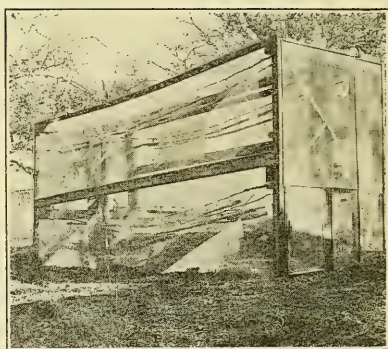
FIG. 1.—The upper cage incloses section of regular commercial cable and two suspension rings. The lower cage incloses section of dead cable used as a check. Insert, view showing repair of telephone cable made necessary by an attack of the lead-cable borer. Photograph by H. E. Burke and insert by R. D. Hartman.
